A1 Certified Home Inspections

Report

01/01/2014

John and Jane Doe

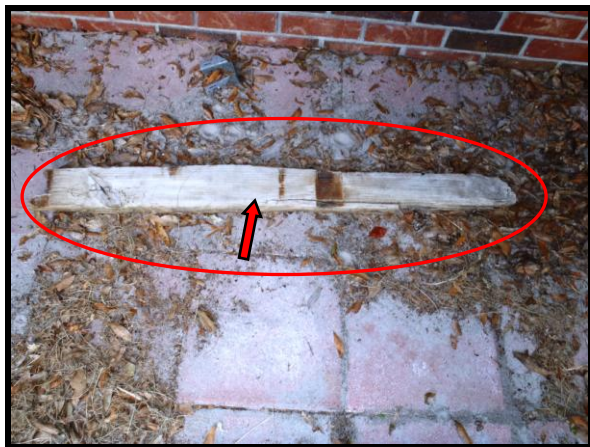
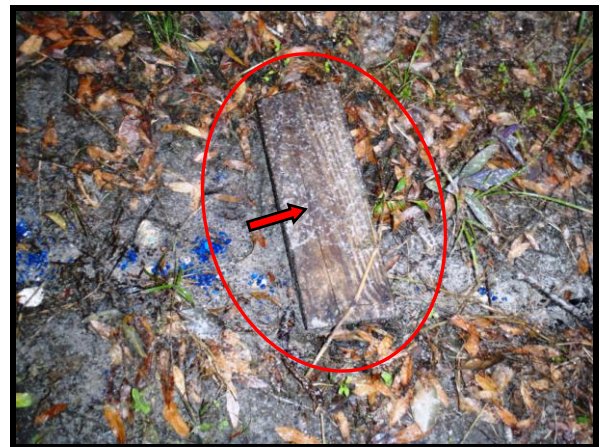
- **Monitor:** This home is in an area known for wood destroying insect activity. Wood destroying insect can do a substantial amount of damage to the wood structural components of a home. Any form of wood/soil contact should be avoided. Controlling dampness in the soil around the perimeter of a home, including below porches and in crawl spaces, is recommended. Preventative chemical treatment, performed by a licensed pest control specialist, is also advisable.
- **Monitor, Improve:** Conditions that are attractive to wood boring insects should be avoided since they can damage the property. These conditions include the storage of wood in damp environments, wood/soil contact around the perimeter of the home (decking, siding, etc.), damp soils, leaky roofs, and unventilated spaces (roofs, garages, crawl spaces, etc.).

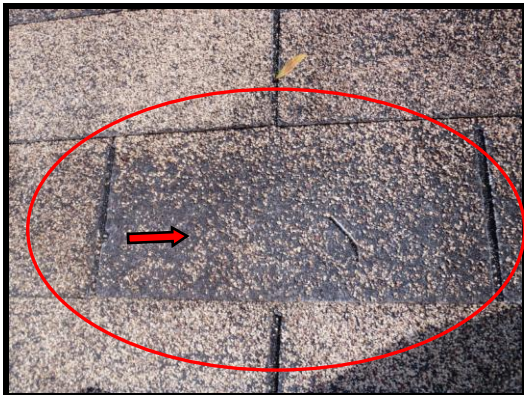
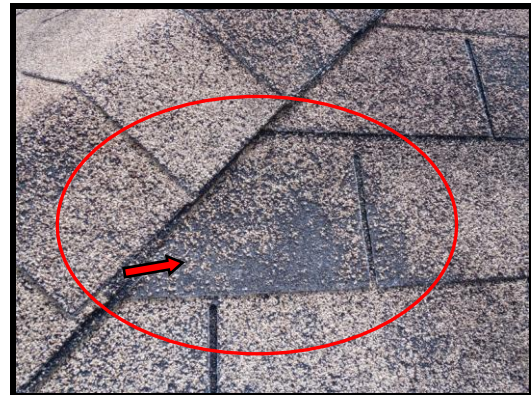
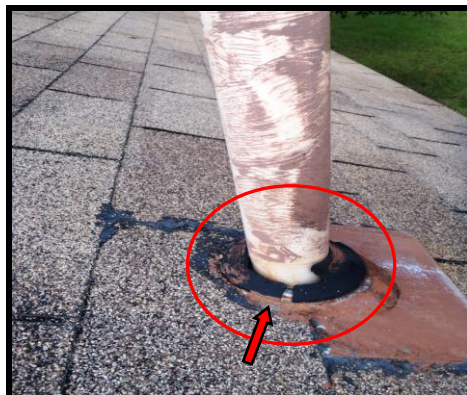
- **Possible Major Concern, Monitor, Repair, Deferred Cost Item:** The roofing is near the end of its life. Minor repairs might be possible to extend the roof life and to defer leaks. Damaged or missing roofing material should be repaired. All roof penetrations (plumbing vents stacks, vents, etc.) should be examined and sealed as necessary. Older roofs are, by their nature, a high maintenance roof. Annual inspection and repair should be anticipated. Expect to replace the roof in the next 5 years.

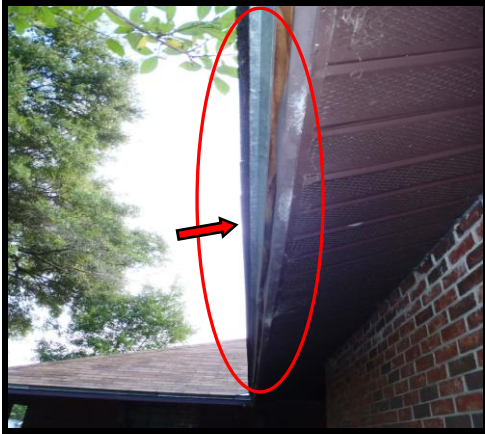
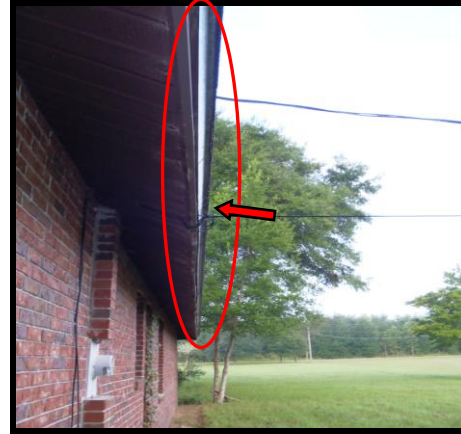
- **Improve:** It is recommended that gutters and downspouts be installed to avoid spilling roof runoff around the building – a potential source of water entry or water damage.

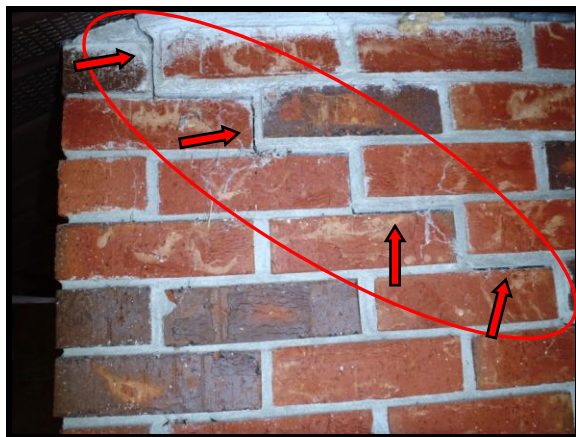
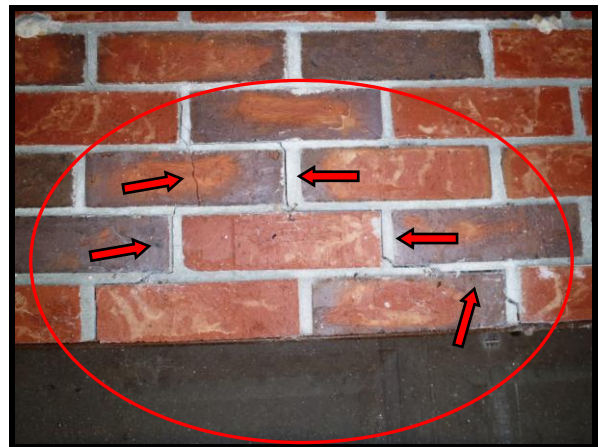
- **Monitor, Improve:** Common minor cracks were observed on the exterior walls of the house. This implies that some minor structural movement has occurred. The location, size, shape of these cracks is very common. The inspection did not find evidence of significant movement requiring immediate major repairs. These photos are only examples, as other areas may exist.

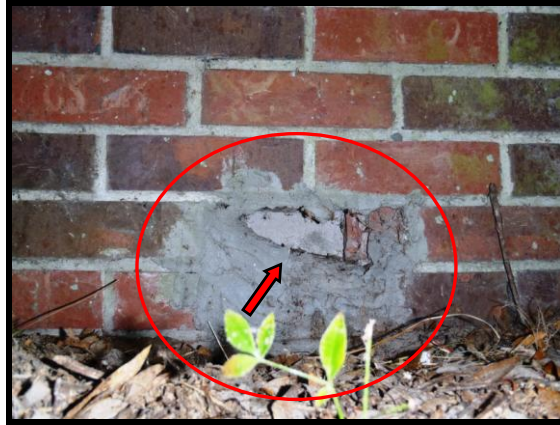
- **Repair:** Minor damage to the brickwork should be repaired to preserve the wall.

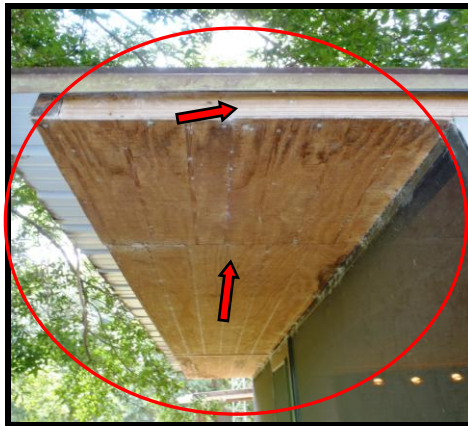
- **Monitor, Improve:** The rear porch soffit and fascia should be painted.

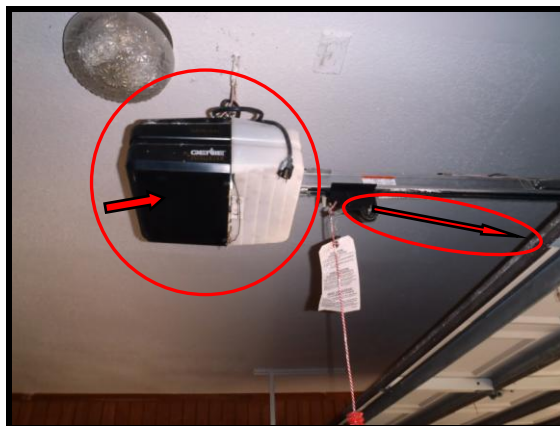
- **Repair:** The garage door opener was inoperative because it was not completely installed. As a result, it could not be tested.

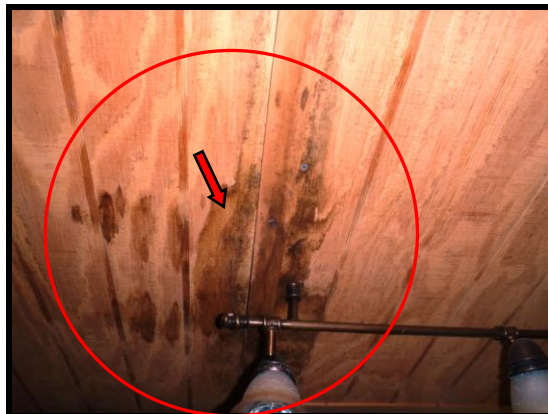
- **Monitor, Improve:** The rear deck/porch cover ceiling has a water stain. This is due to the fact that there are no gutters installed on the main home. As a result, the rain comes down the valley of the roof and hits the rear porch deck cover in a concentrated area in large volumes. Some water is forced through. Gutters are needed in this location.

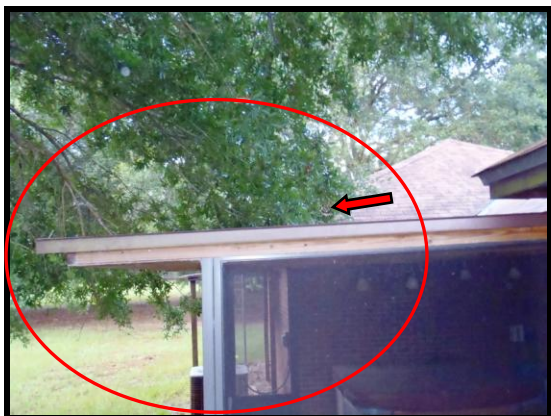
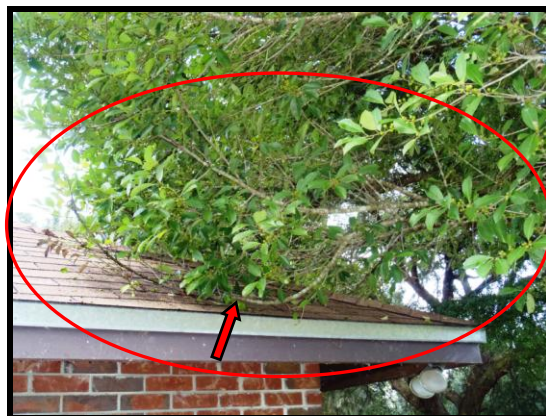
- **Monitor, Improve:** Tree branches should be trimmed away from the house and roof to avoid damage to the building.

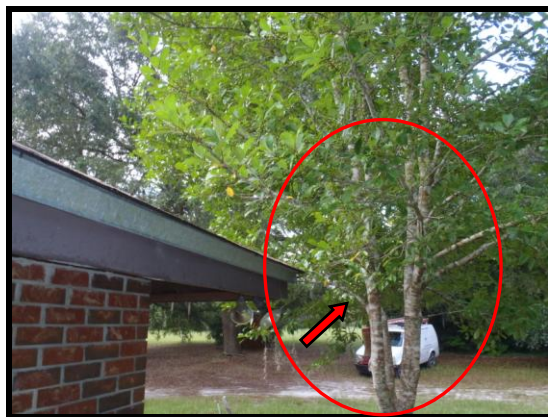
- **Monitor, Improve:** The proximity of the closest trees could disrupt drainage pipes, cause mechanical damage to the exterior of the house, or influence the foundation over time. You should consider removal of the closest trees.

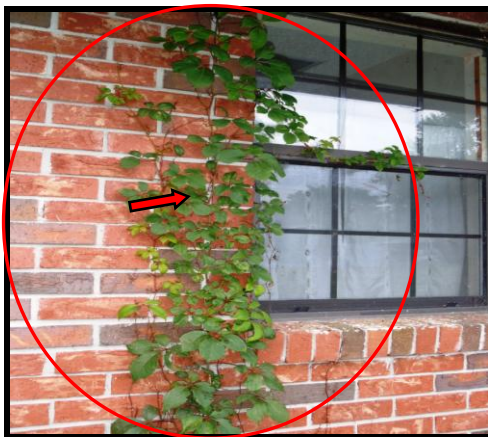
- **Monitor, Improve:** Vines growing on exterior walls should be kept trimmed away from siding, window trims, and the eaves to reduce risk of insect and water damage.

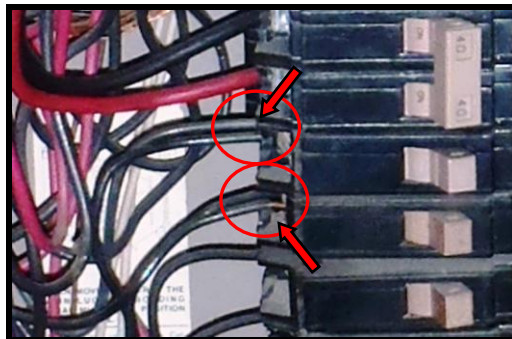
- **Repair, Safety Issue:** Two circuits within the main distribution panel that are doubled up (referred to as “double taps”) should be separated. Each circuit should be served by a separate fuse or breaker.

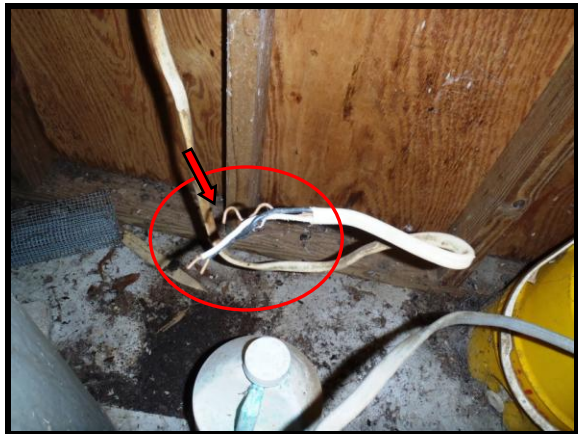
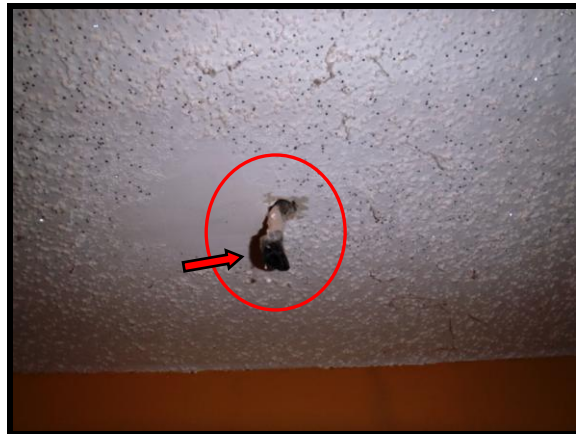
- **Repair, Safety Issue:** Abandoned wiring should be removed or appropriately terminated with a box and cover.

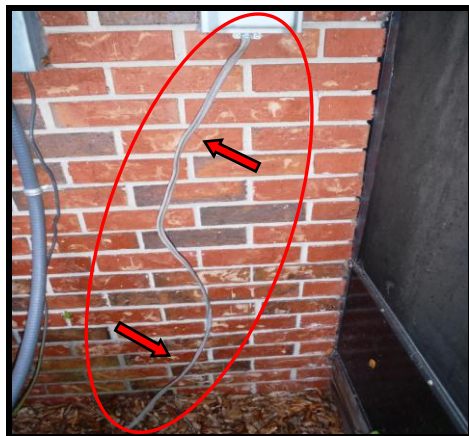
- **Repair, Safety Issue:** Wiring exposed on exterior finishes should be relocated or protected by a rigid conduit.

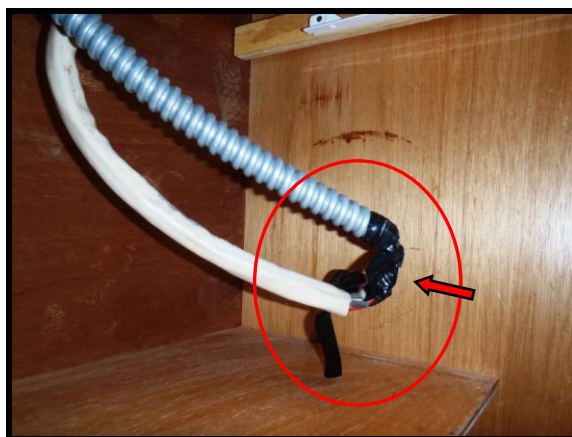
- **Repair, Safety Issue:** The improper electrical connection for the stove cook-top should be repaired. All electrical connections should be made inside junction boxes fitted with cover plates.

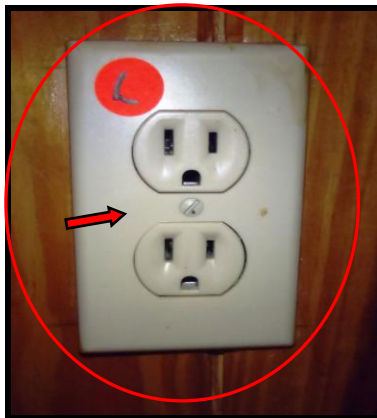
- **Repair, Safety Issue:** An outlet is loose. It should be repaired.

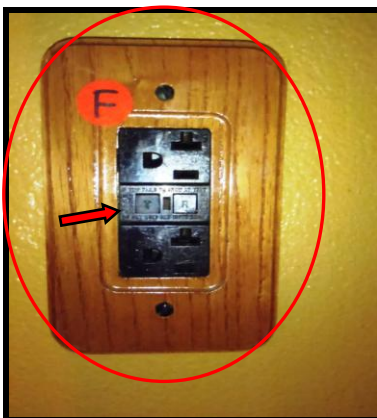
- **Repair, Safety Issue:** One of the ground fault circuit interrupter (GFCI) outlets in the kitchen did not respond correctly to testing during the inspection. This receptacle should be replaced.

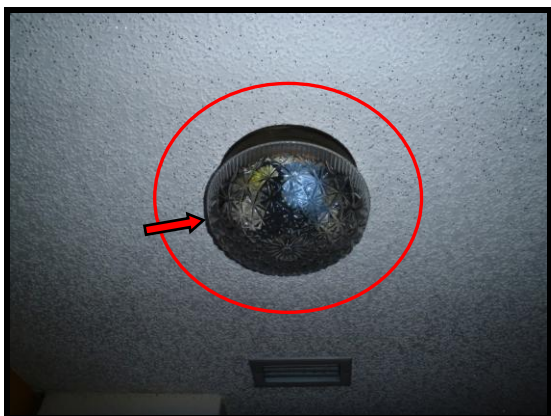
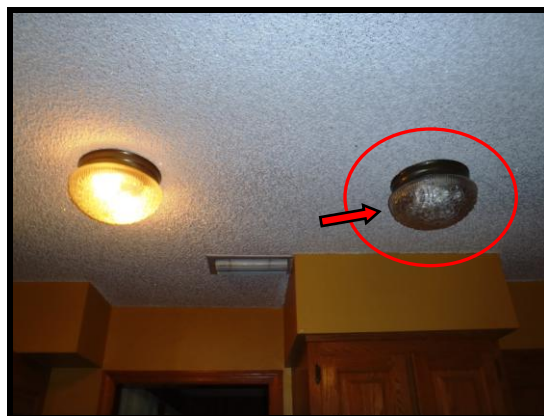
- **Monitor, Improve:** Several of the lights are inoperative. If the bulbs are not blown, the circuit should be repaired.

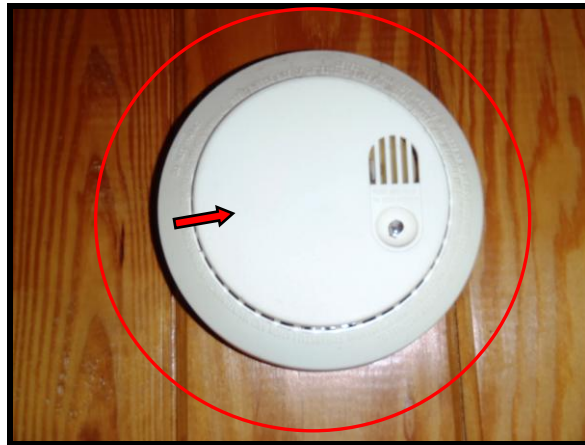
- **Repair, Safety Issue:** All four of the smoke detectors did not respond to testing. It is suspected that the batteries in the smoke detectors are dead. This should be investigated.

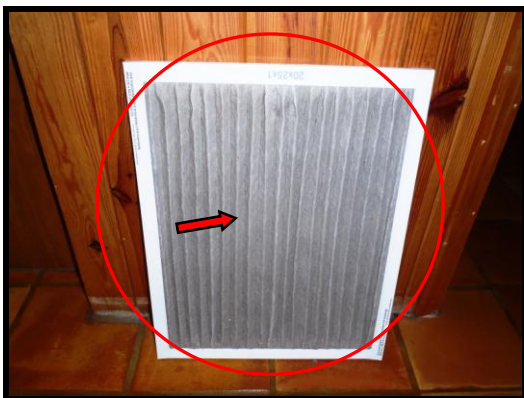
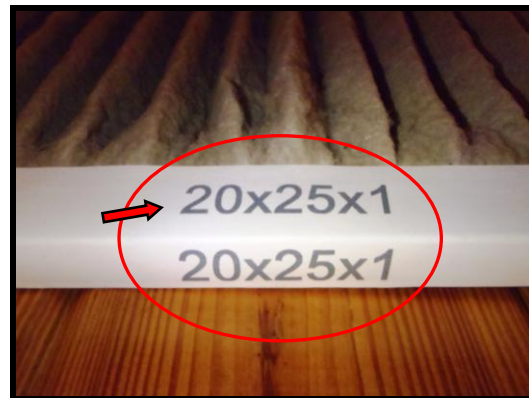
- **Monitor, Improve:** The present air filter is very dirty. White pleated filters should be used, and replaced every 30 days.

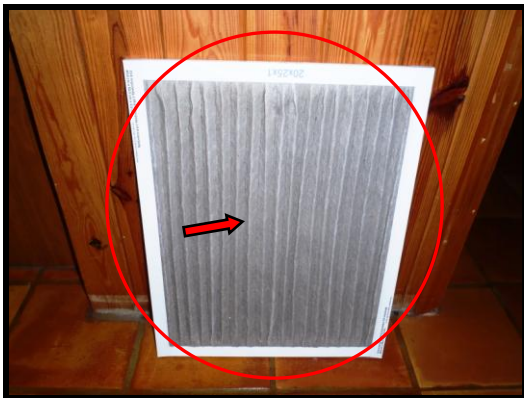
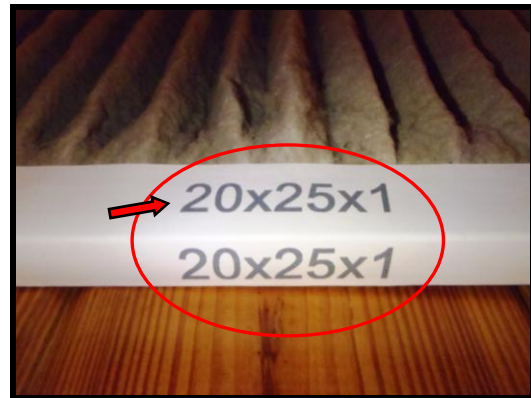
- **Monitor, Improve:** The present air filter is very dirty. White pleated filters should be used, and replaced every 30 days.

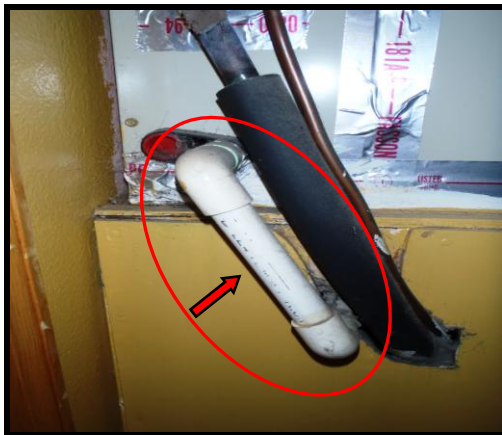
- **Monitor, Deferred Cost Item:** Most HVAC systems have a typical life expectancy of 10 to 15 years. The existing unit (1991) has passed this age range. One cannot predict with certainty when replacement will become necessary, but a higher level of maintenance should be expected.
- **Improve:** The drain line for the interior air conditioning unit should have a "float switch" installed to shut down the unit in the event that the line becomes blocked which will prevent the drain water from spilling out onto the floor.

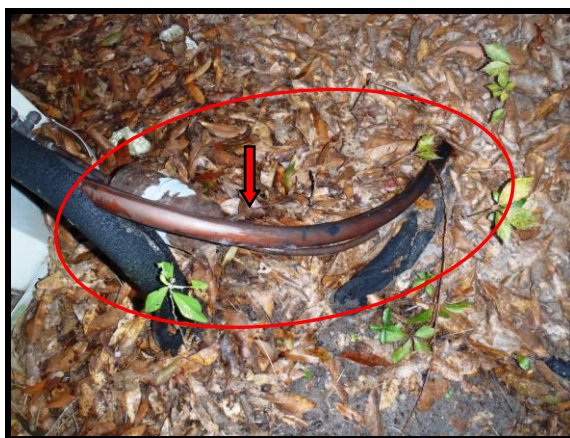
- **Monitor, Improve:** Damaged and or missing insulation on refrigerant lines should be repaired. These outside lines should be insulated all the way to the compressor unit to prevent loss of temperature in the lines.

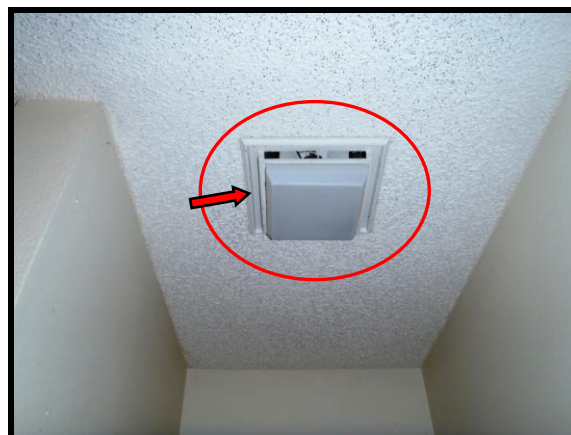
- **Improve:** Both of the bathroom exhaust fans are excessively noisy.

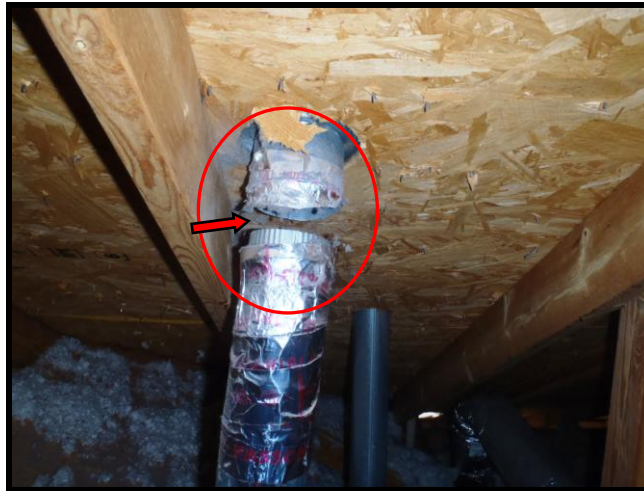
- **Repair, Safety Issue:** The exhaust vent pipe for the dryer is disconnected inside the attic. This is a safety issue and should be repaired before the dryer is used.

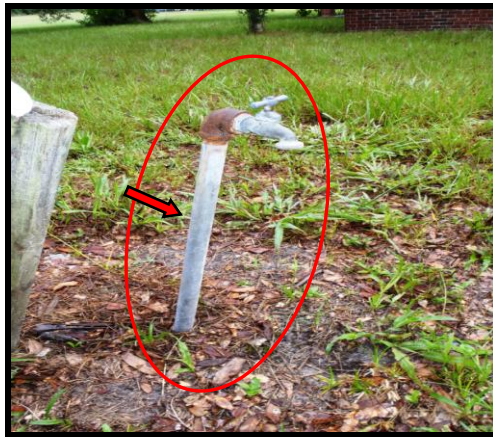
- **Monitor, Improve:** Exterior supply piping may be susceptible to freezing during extremely cold weather. Heating or insulating this pipe would be wise.

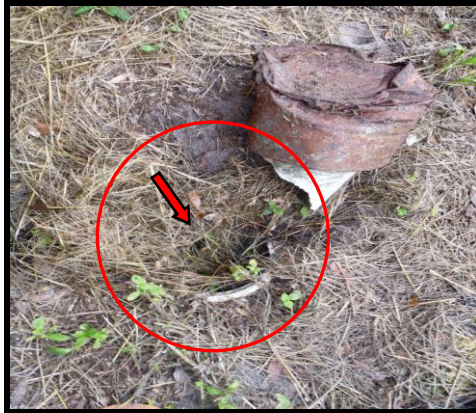
- **Repair:** One of the exterior plumbing clean out ports for the septic tank is broken, and must be repaired to prevent foreign matter from entering the system.

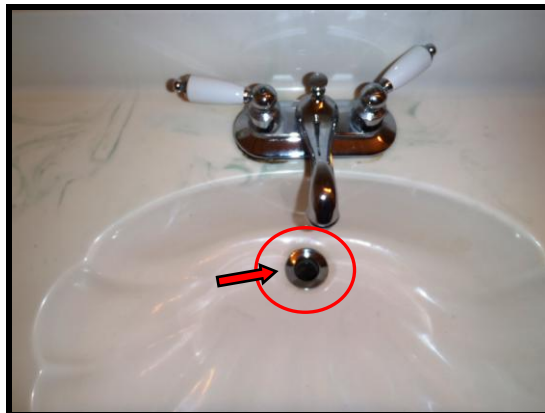
- **Improve:** Three of the four bathroom sink drain stoppers are missing.

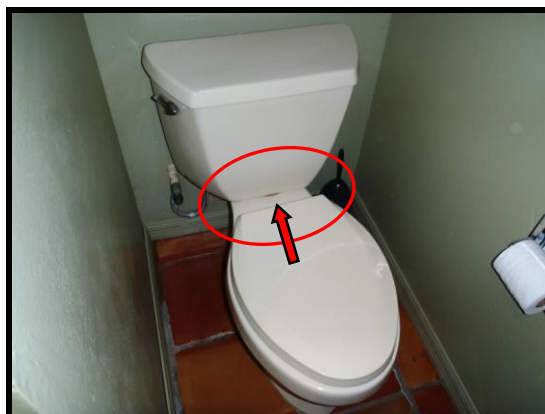
- **Repair:** The hallway bathroom toilet is leaking where the tank section connects to the bowl.

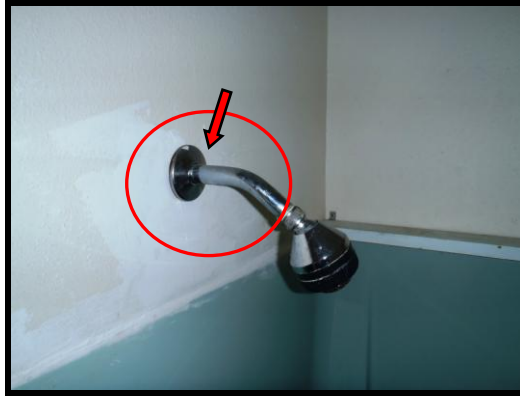
- **Improve:** Both of the shower head pipes and the bathtub spout are not properly fastened inside the wall. They are not leaking inside the wall, but there is a lot of movement when used.

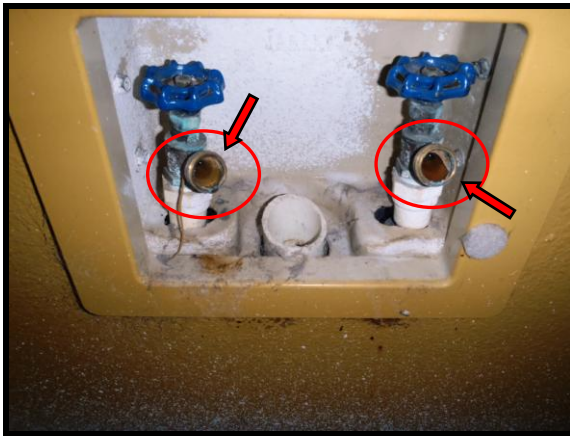
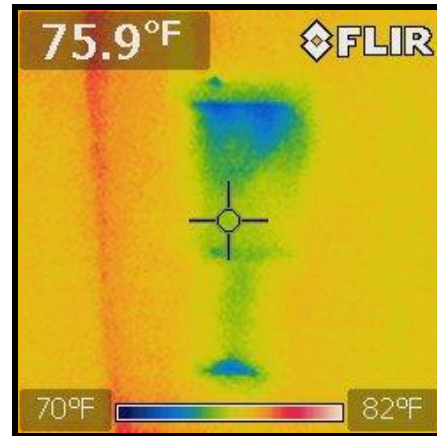
- **Repair:** The laundry bib valves do not shut off completely. As a result, the drywall wall below the bibs is wet.

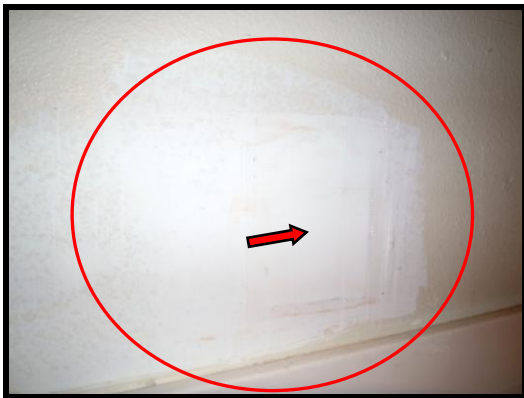
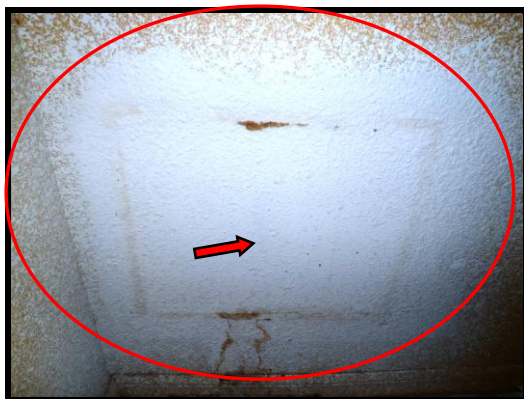
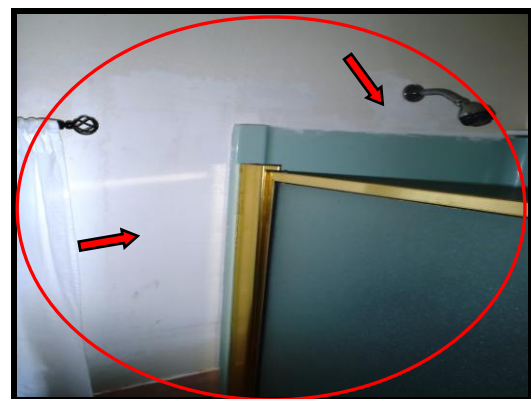
- **Improve:** Evidence of patching was detected on several of the walls.

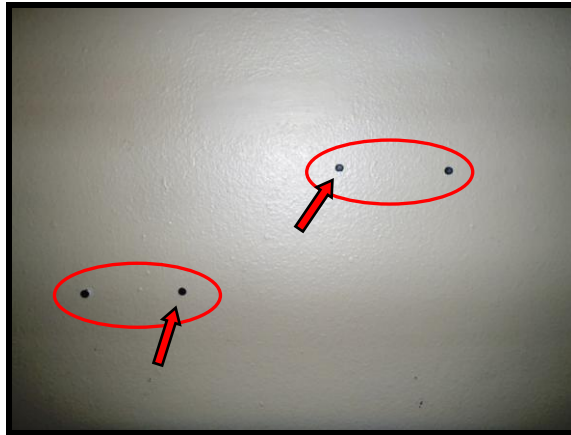
- **Improve:** Typical drywall flaws (nail holes, marks, scratches, etc.) were observed throughout the home.

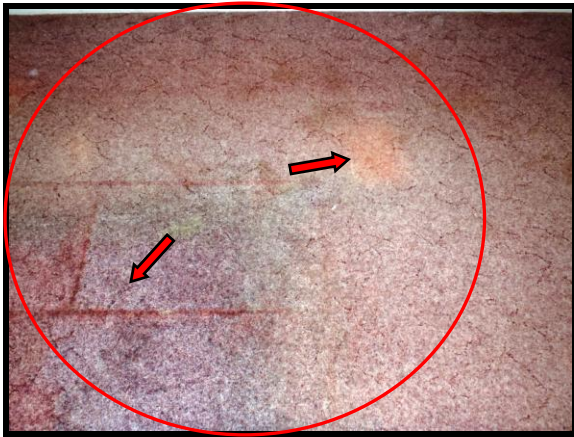
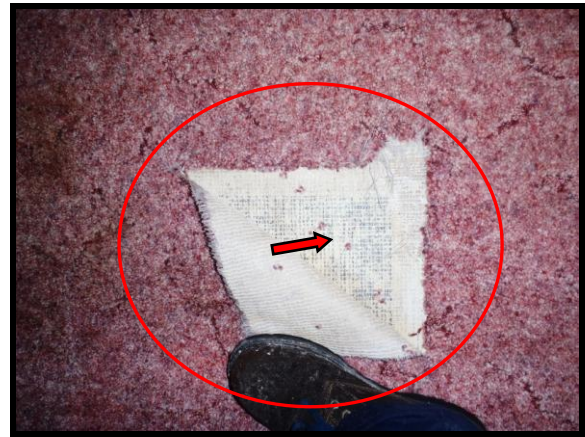
- **Improve:** The carpet in the Master bedroom is in poor condition.

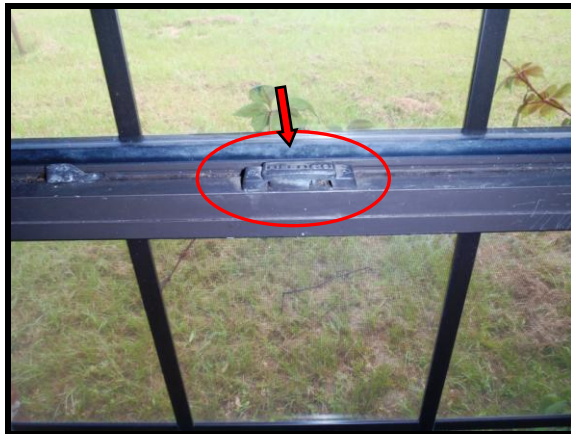
- **Improve:** The window lock is damaged on one of the Master bathroom windows.

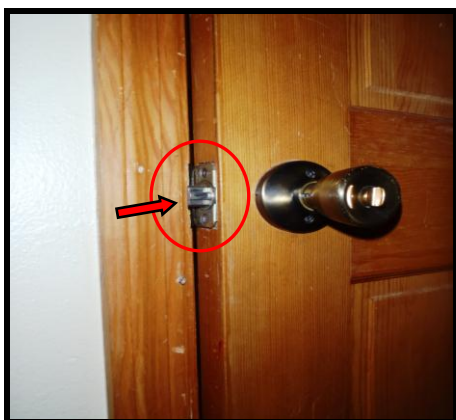
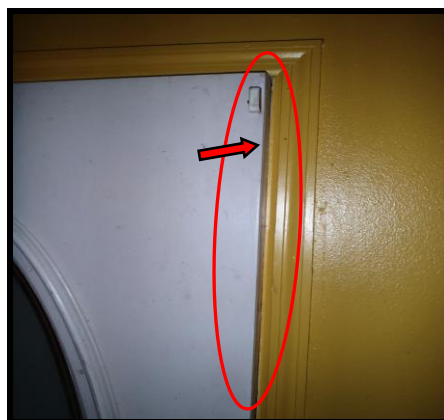
- **Monitor, Improve:** Doors (including closets) should be trimmed or adjusted as necessary to work properly.

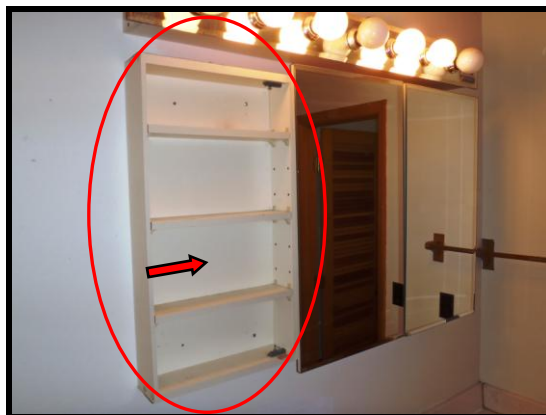
- **Repair:** One of the medicine cabinet doors is missing in the Master bathroom.

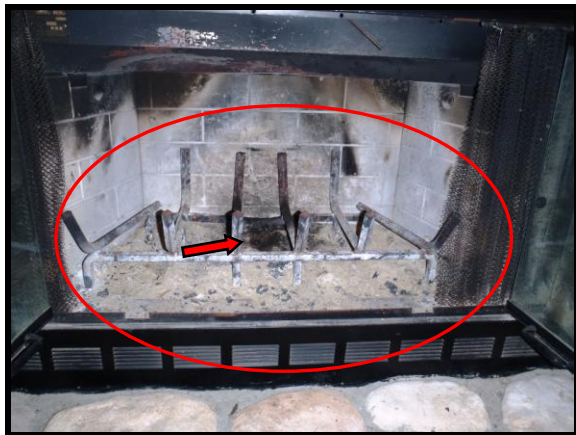
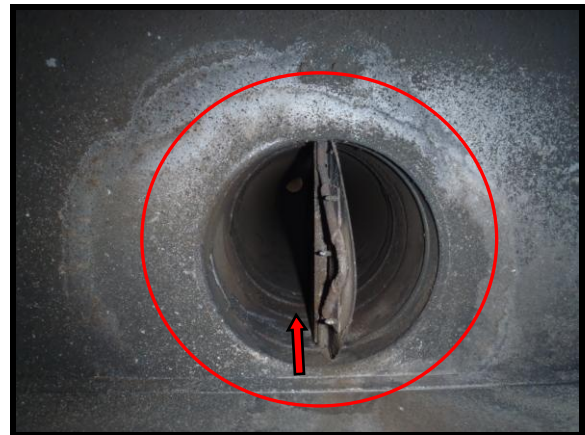
- **Improve, Safety Issue:** The fireplace and chimney should be inspected and cleaned prior to operation.

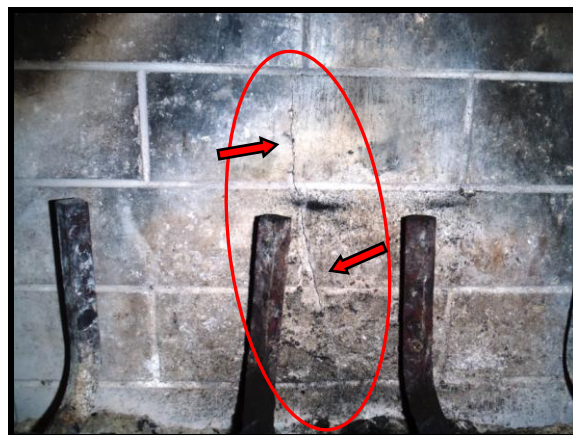
- **Repair, Safety Issue:** The rear wall of the fireplace firebox is damaged and should be repaired for improved safety.

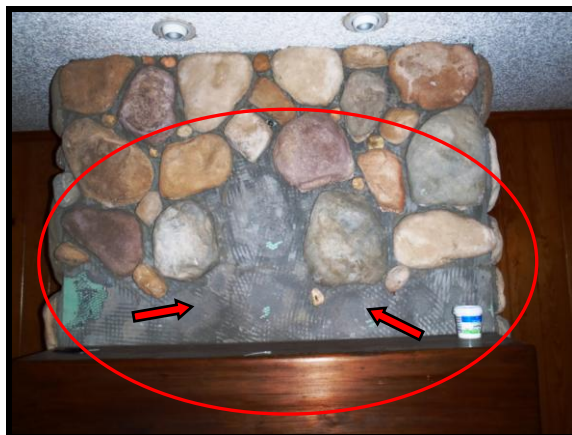
- **Improve:** Many of the stones on the outside the fireplace are missing.

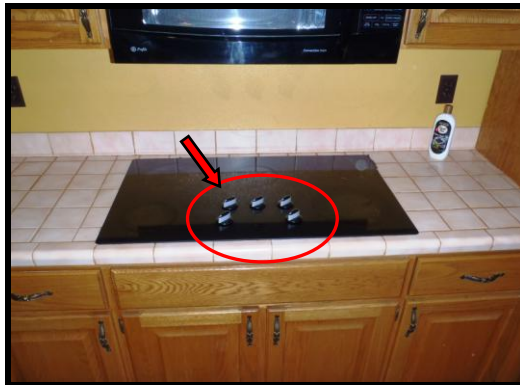
- **Monitor, Improve:** When all 5 of the burners on the electric cook-top are on "High", and the oven is also in use, the 30 Amp circuit breaker trips out. If this becomes an issue, the circuit break can be replaced with a 50 Amp circuit breaker.

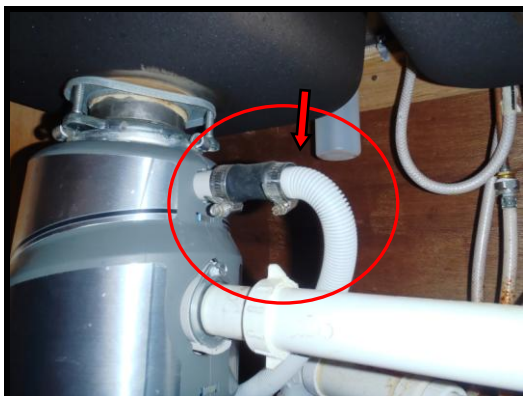
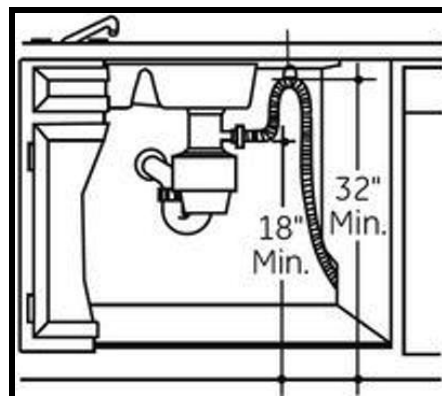
- **Improve:** The dishwasher drain line does not have a "High Loop" to prevent waste water from flowing back into the machine.

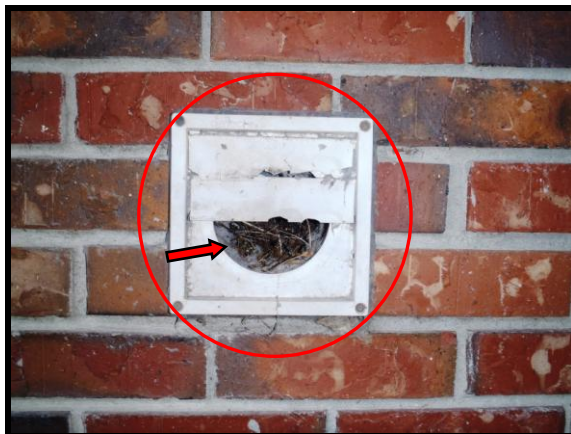
- **Repair:** The exterior clothes dryer exhaust vent cover is damaged and should be replaced.
