A1 Certified Home Inspections

Report

01/01/2014

John and Jane Doe

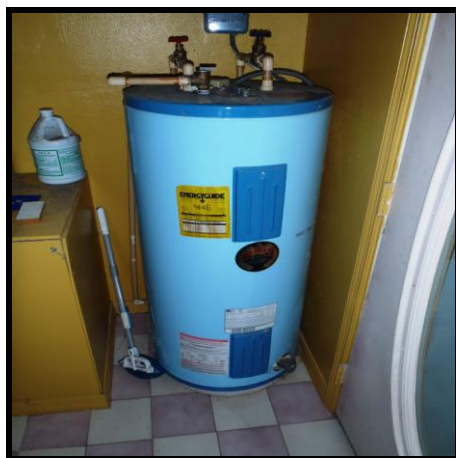
Photo of the hot water heater and an IR photo showing the internal temperature of the water

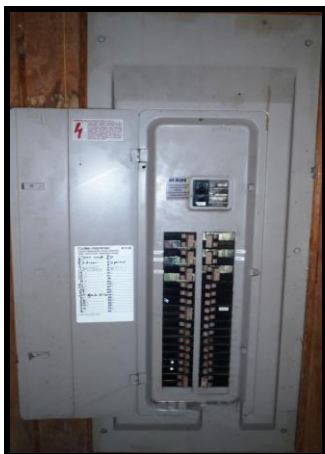
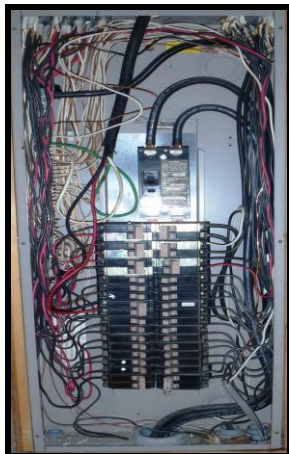
Photos of the exterior and interior of the main circuit breaker panel and an IR photo showing the internal temperature

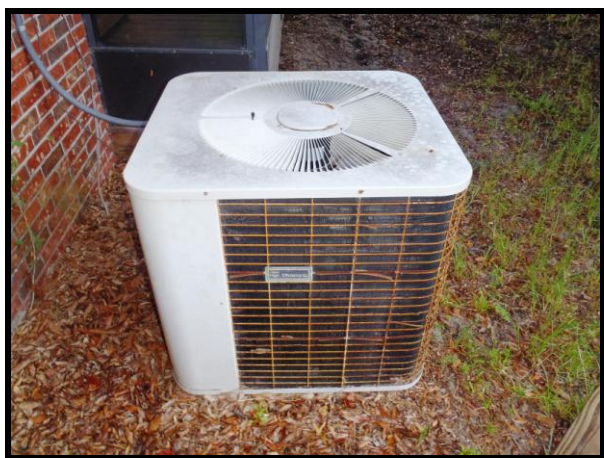
Photo of the exterior A/C compressor

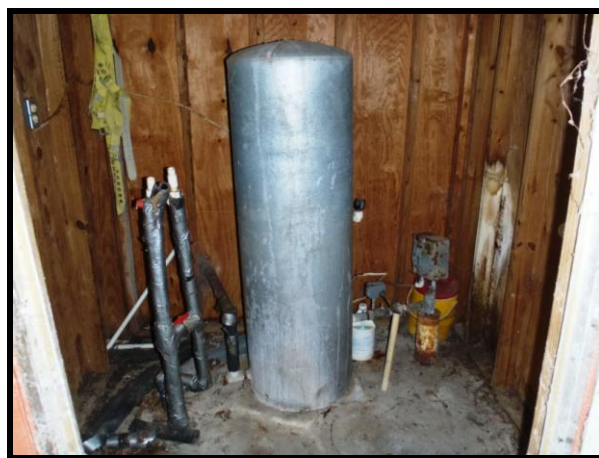
Photo of the well pump station

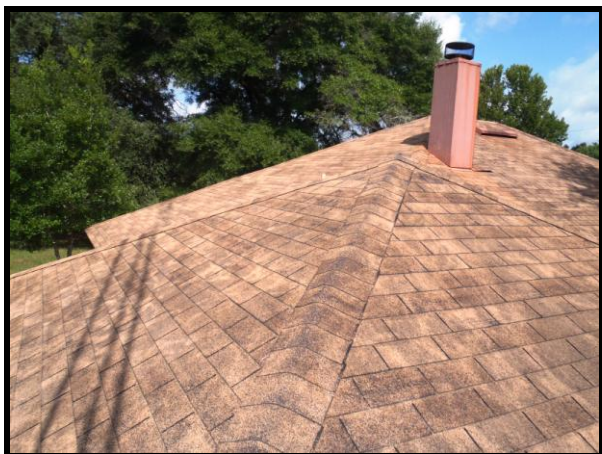
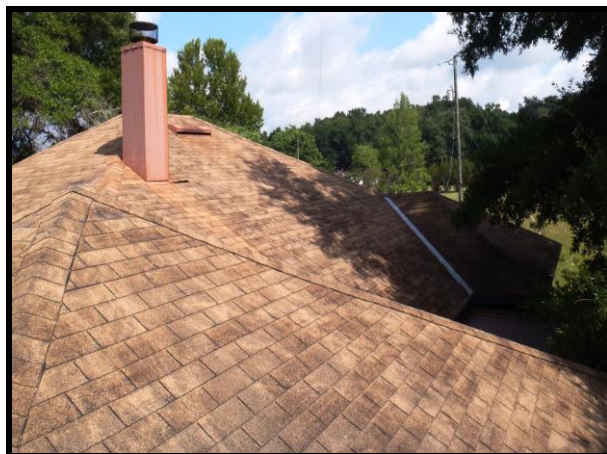
Random photos taken from atop the roof

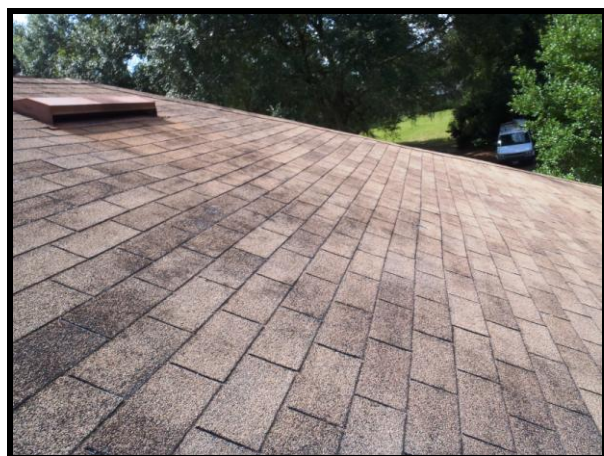
Random photos taken from atop the roof
